# Shared Island Initiative PEATLAND PROGRAMME

## CASE STUDY

### Wicklow Mountains National Park (WMNP) Restoration Project

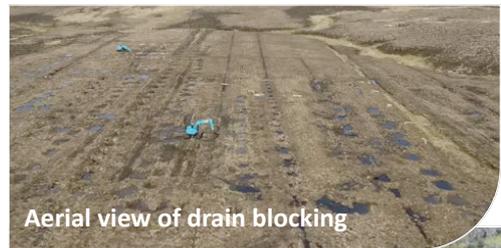
Aerial view of drain blocking

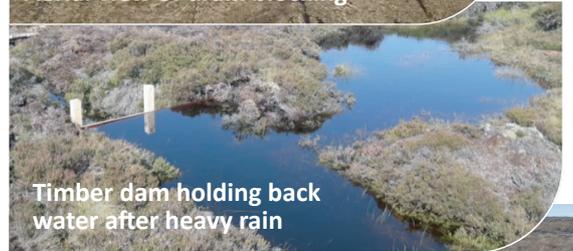
Timber dam holding back water after heavy rain

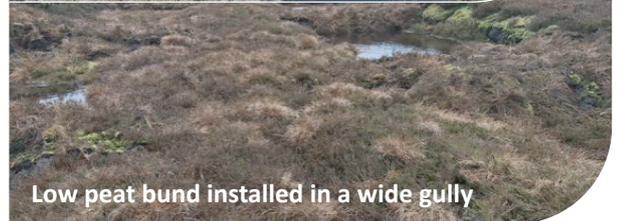
Low peat bund installed in a wide gully
